Section Inspection - 23/10/2018 - F1X

Section 3	Inspection 3	Date 23/10/18	Time 9:28	Client's Job Ref Not Specified	Weather No Rain Or Snow	Pre Cleaned Y	PLR F1X
Operator Daniel Knight		Vehicle BL18 LKK		Camera Coiler	Preset Length Not Specified	Legal Status Not Specified	Alternative ID Not Specified

Town or Village:	Kinross	Inspection Direction:	Downstream	Upstream Node:	F1
Road:	Kellieside Park	Inspected Length:	18.22 m	Upstream Pipe Depth:	
Location:	Road	Total Length:	18.22 m	Downstream Node:	F2
Surface Type:		Joint Length:	6.00 m	Downstream Pipe Depth:	1.230 m
Use:	Foul	Pipe Shape:	Circular		
Type of Pipe:	Gravity drain/sewer	Dia/Height:	150 mm		
Year Constructed:		Pipe Material:	Polyvinyl chloride		
Flow Control:	No flow control	Lining Type:	No Lining		
Inspection Purpose:	Investigation of infiltration problems	Lining Material:	No Lining

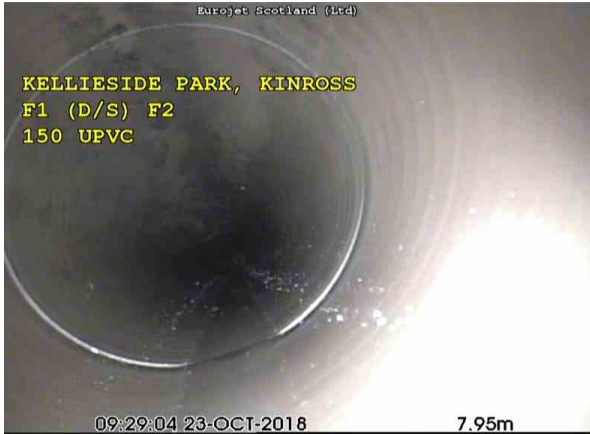
<table><tr> <td style="text-align: right;">Depth: m</td> <td></td> <td></td> <td></td> <td></td> <td></td> <td></td> </tr><tr> <td></td> <td style="text-align: center;">7.92</td> <td style="text-align: center;">D</td> <td style="text-align: left;">Deformed drain or sewer, 5%</td> <td style="text-align: center;">00:00:36</td> <td></td> <td style="text-align: center;">1</td> </tr></table>

, 00:00:36, 7.92 m
 Deformed drain or sewer, 5%

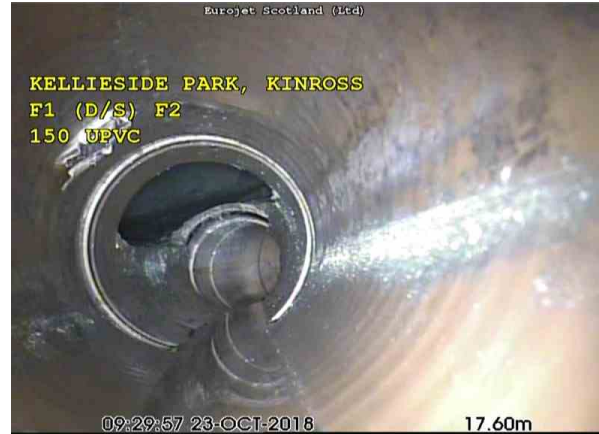
<table><tr> <td style="text-align: right;">Depth: m</td> <td></td> <td></td> <td></td> <td></td> <td></td> <td></td> </tr><tr> <td></td> <td style="text-align: center;">17.60</td> <td style="text-align: center;">B</td> <td style="text-align: left;">Broken pipe from 10 o'clock to 11 o'clock</td> <td style="text-align: center;">00:01:31</td> <td></td> <td style="text-align: center;">4</td> </tr><tr> <td></td> <td style="text-align: center;">17.60</td> <td style="text-align: center;">D</td> <td style="text-align: left;">Deformed drain or sewer, 5%: PIPE BROKEN</td> <td style="text-align: center;">00:01:31</td> <td></td> <td style="text-align: center;">1</td> </tr></table>

, 00:01:31, 17.60 m
 Broken pipe from 10 o'clock to 11 o'clock

Comments:
Recommendations: PATCH REPAIR ADVISED TO COVER BROKEN PIPE AT 17.60M FROM F1

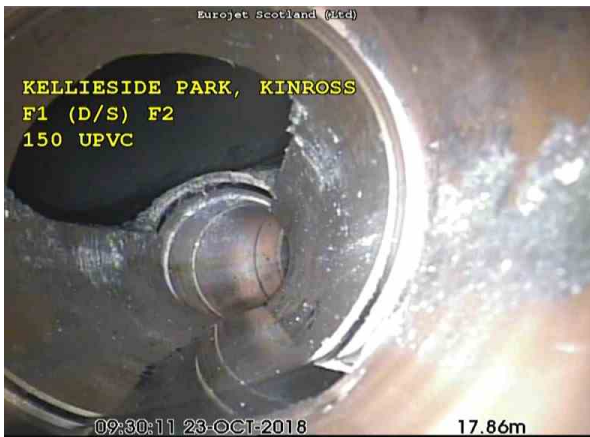
<table><tr> <td style="text-align: right;">Depth: m</td> <td></td> <td></td> <td></td> <td></td> <td></td> <td></td> </tr><tr> <td></td> <td style="text-align: center;">17.86</td> <td style="text-align: center;">OJM</td> <td style="text-align: left;">Open joint, medium</td> <td style="text-align: center;">00:01:46</td> <td></td> <td style="text-align: center;">1</td> </tr></table>

, 00:01:46, 17.86 m
 Open joint, medium
