Section Inspection - 23/10/2018 - F1X

Section 3	Inspection 3	Date 23/10/18	Time 9:28	Client's Job Ref Not Specified	Weather No Rain Or Snow	Pre Cleaned Y	PLR F1X
Operator Daniel Knight		Vehicle BL18 LKK		Camera Coiler	Preset Length Not Specified	Legal Status Not Specified	Alternative ID Not Specified

Town or Village:	Kinross	Inspection Direction:	Downstream	Upstream Node:	F1
Road:	Kellieside Park	Inspected Length:	18.22 m	Upstream Pipe Depth:	
Location:	Road	Total Length:	18.22 m	Downstream Node:	F2
Surface Type:		Joint Length:	6.00 m	Downstream Pipe Depth:	1.230 m
Use:	Foul	Pipe Shape:	Circular		
Type of Pipe:	Gravity drain/sewer	Dia/Height:	150 mm		
Year Constructed:		Pipe Material:	Polyvinyl chloride		
Flow Control:	No flow control	Lining Type:	No Lining		
Inspection Purpose:	Investigation of infiltration problems	Lining Material:	No Lining

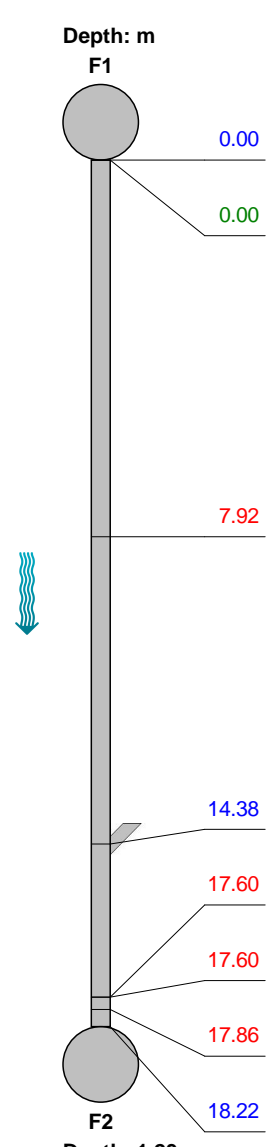
<table><tr> <td style="text-align: right;">Depth: m</td> <td></td> <td></td> <td></td> <td></td> <td></td> <td></td> </tr><tr> <td></td> <td style="text-align: center;">7.92</td> <td style="text-align: center;">D</td> <td style="text-align: left;">Deformed drain or sewer, 5%</td> <td style="text-align: center;">00:00:36</td> <td></td> <td style="text-align: center;">1</td> </tr><tr> <td></td> <td style="text-align: center;">17.60</td> <td style="text-align: center;">B</td> <td style="text-align: left;">Broken pipe from 10 o'clock to 11 o'clock</td> <td style="text-align: center;">00:01:31</td> <td></td> <td style="text-align: center;">4</td> </tr><tr> <td></td> <td style="text-align: center;">17.60</td> <td style="text-align: center;">D</td> <td style="text-align: left;">Deformed drain or sewer, 5%: PIPE BROKEN</td> <td style="text-align: center;">00:01:31</td> <td></td> <td style="text-align: center;">1</td> </tr><tr> <td></td> <td style="text-align: center;">17.86</td> <td style="text-align: center;">OJM</td> <td style="text-align: left;">Open joint, medium</td> <td style="text-align: center;">00:01:46</td> <td></td> <td style="text-align: center;">1</td> </tr></table>

Comments:
Recommendations: PATCH REPAIR ADVISED TO COVER BROKEN PIPE AT 17.60M FROM F1
